Aloha Airlines Flight 243

Boeing 737-200

April 28, 1988

Honolulu, HI

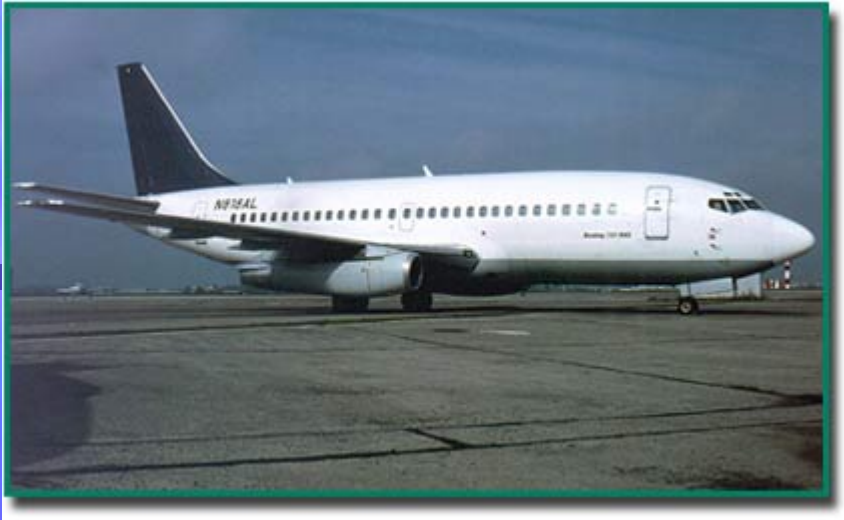
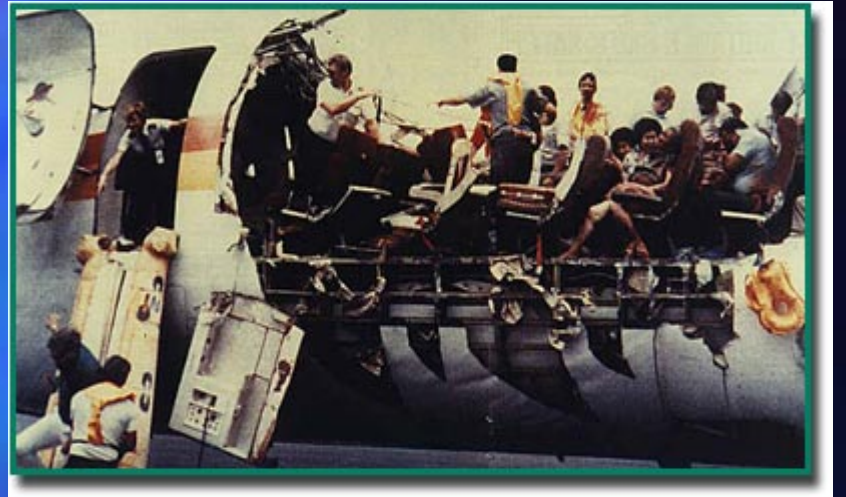
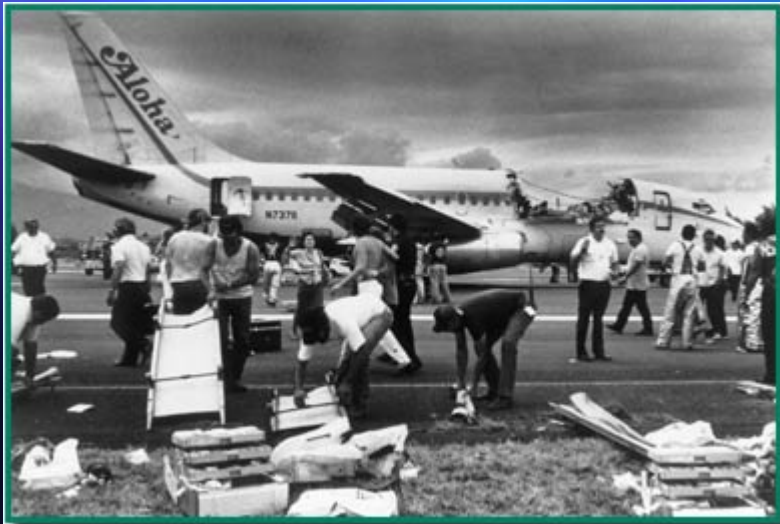
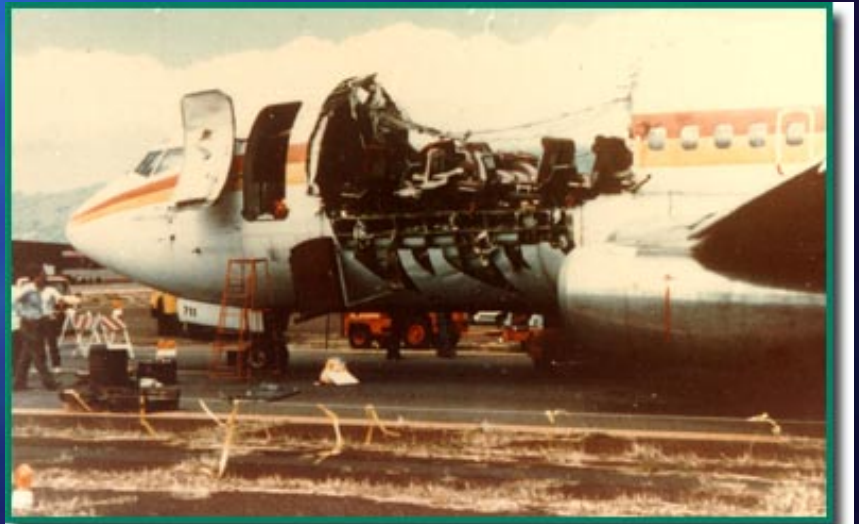
Successful landing in Honolulu:

- Separated section extended from cabin floor, equivalent to ~1/4 of fuselage length
- One fatality, seven serious injuries
- The fatality was a flight attendant who had been standing at row 5, and was swept out of the cabin
- A flight attendant at row 15 was thrown to the floor and slightly injured. Flight attendant at row 2 sustained serious injuries from flying debris
- When depressurization occurred, all passengers were in their seats, and seat belt sign was already illuminated

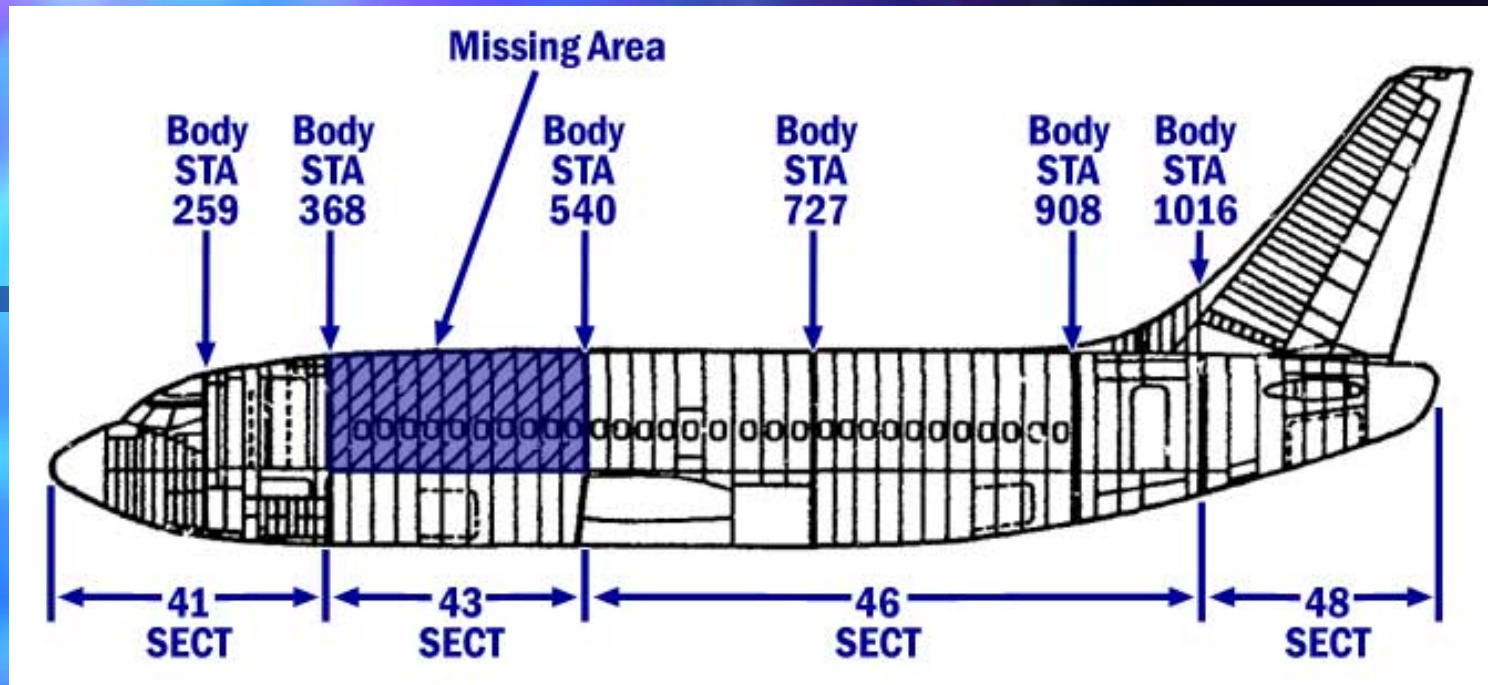
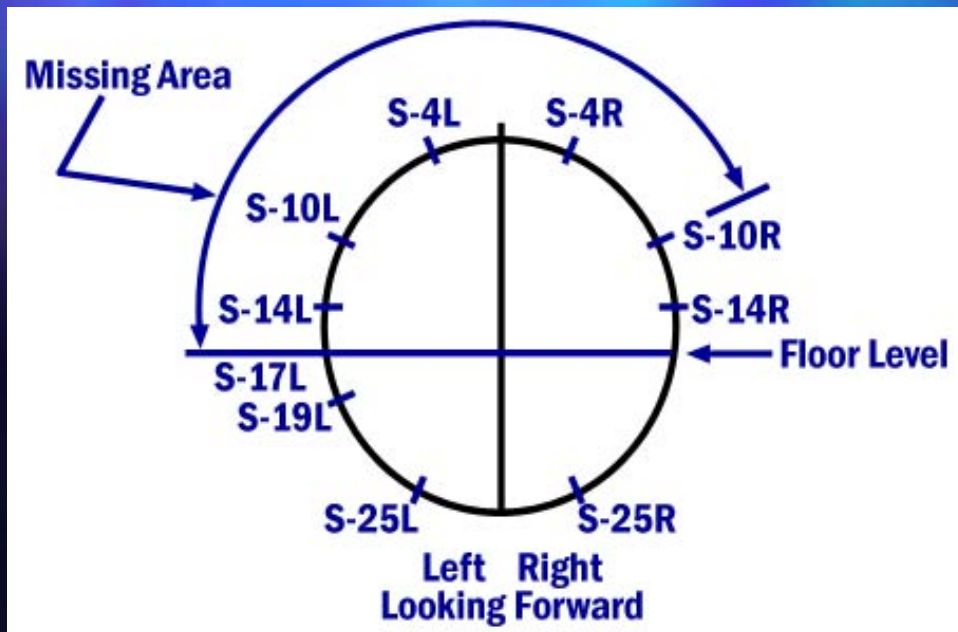
Damage Summary:

- At the time of the accident, the airplane had 89,680 flight cycles, and 35,496 flight hours
- After the accident, a passenger reported that as she boarded, she noticed a large vertical fuselage crack, but didn't mention it to anyone
- Final damage consisted of the total loss of a major portion of the upper crown, and damage to other structure in section 43
- Damage extended from the main entrance door, aft about 18 feet. Airplane was determined to be damaged beyond repair, and was dismantled on site

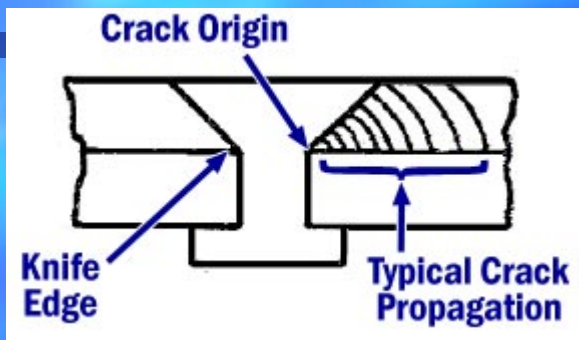
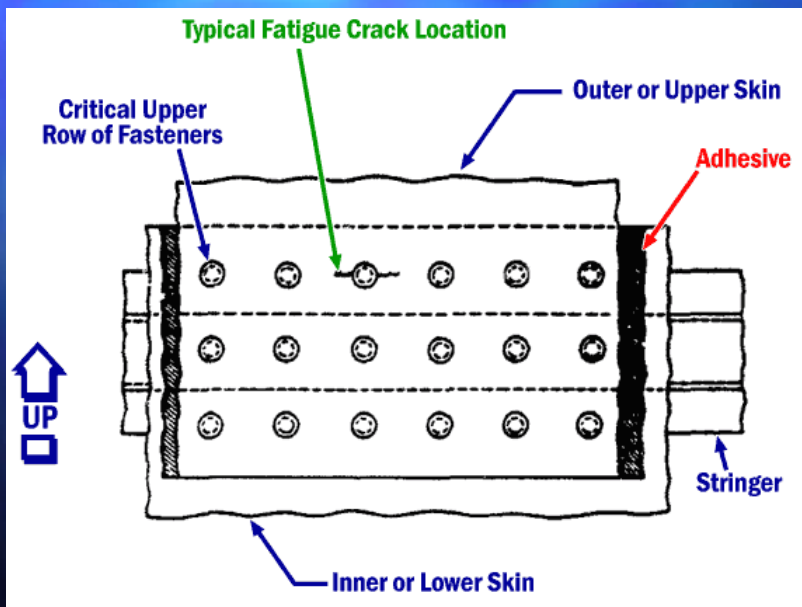
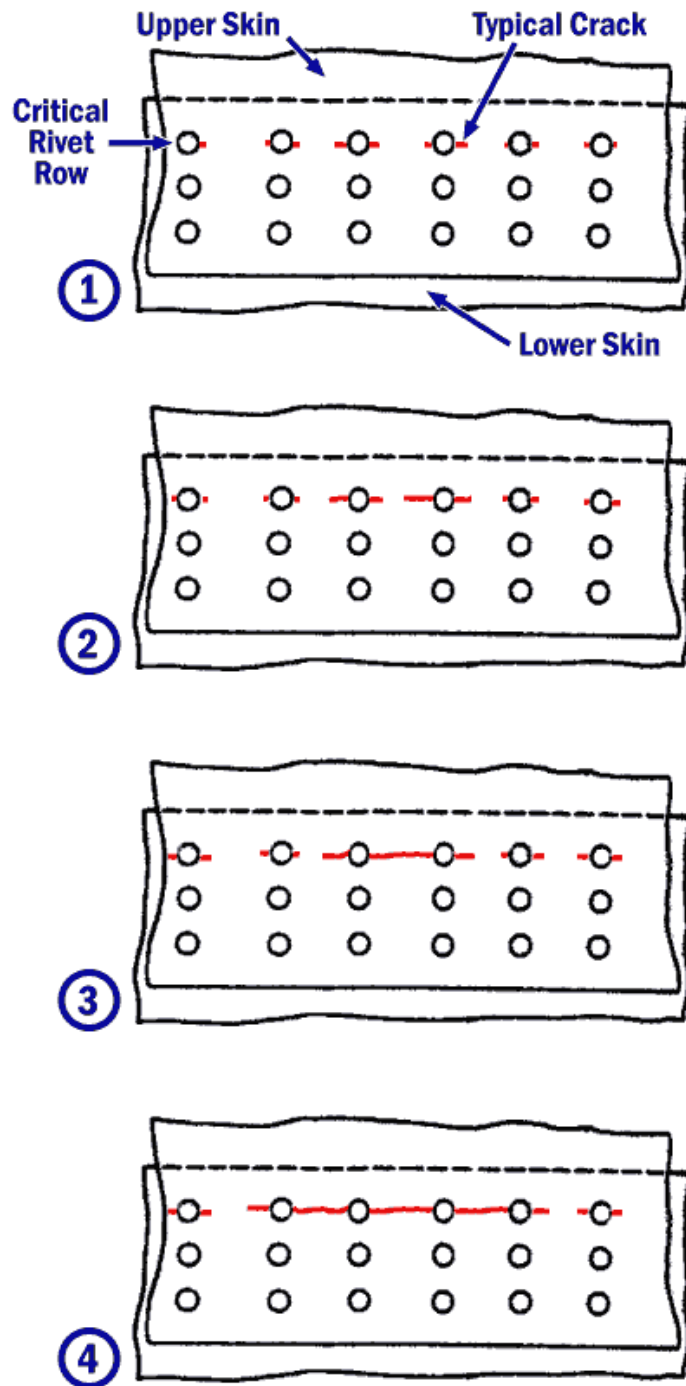
Crack growth (Cont'd)

Crack growth

- When cracks form at the “knife” edges of holes, cracks propagate from hole edges.
 - As cracks grow, they may link up
 - Over time, this linking up of cracks can lead to catastrophic failure

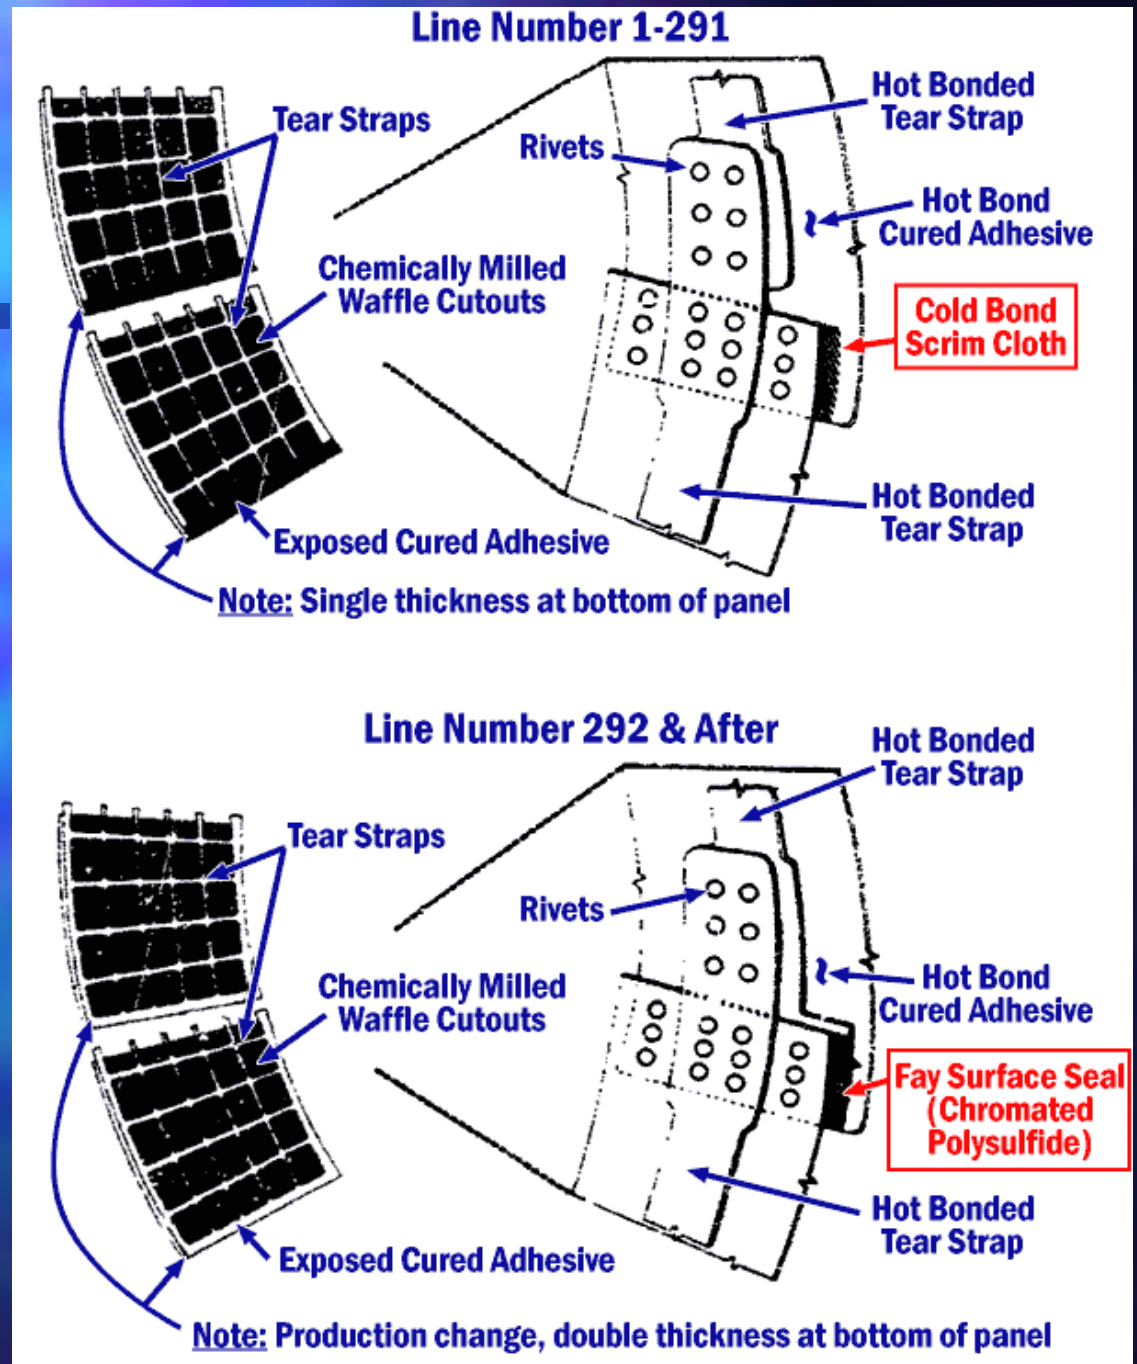
Fuselage Lap Joint Construction:

- “Old” process utilized cold bonding, with fasteners used to maintain surface contact in joint, allowing bonding adhesive to carry/transfer load between skin panels
- Adhesive was breaking down, causing fasteners to carry load for which they were not intended
- Repeated pressurization cycles led to formation of cracks at the “knife” edges of fastener holes

- The cold bonding process (scrim cloth) was replaced by a joint assembled with faying surface sealant (Chromated Polysulfide)
- The over-lapping upper skin at the lap joint was changed from a single 0.036" skin to a configuration with an 0.036" skin plus 0.036" doubler hot bonded together
- This construction improved the known problems with the joint by:
 - Eliminating the knife-edge fatigue detail, which resulted from the countersunk rivets in a disbanded upper skin
 - Eliminating the corrosion concern associated with the scrim cloth, which could wick moisture into the lap joint

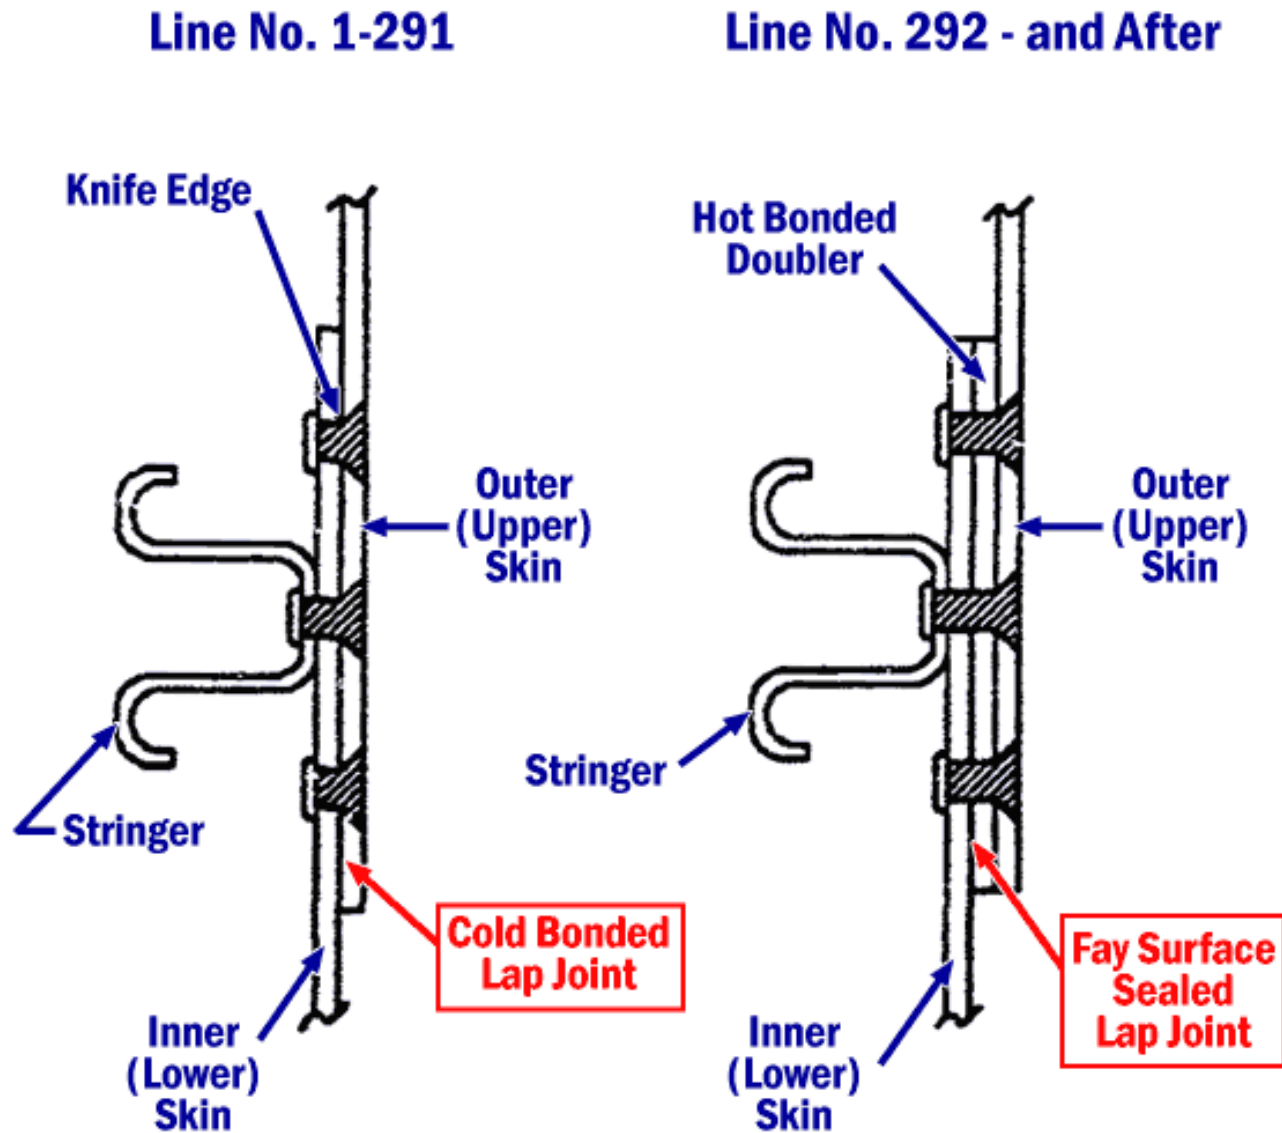
Fuselage Lap Joint Construction:

Accident airplane was constructed using "old" method

Note: Skin Thickness Dimension 0.036 in.
Not to Scale: Skin Thickness is enlarged to show detail

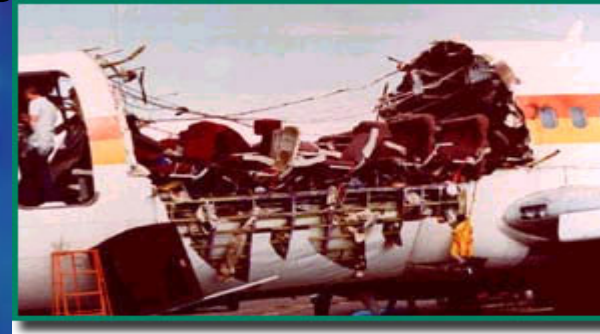
Aloha's Aircraft Maintenance Human Factors Lessons Learned.

- Inspectors working under pressure
- **Inspections done at night –circadian rhythm upset**
- Inspectors suspended by safety harnesses
- Required to inspect 1,300 rivets
- Documentation complicated & subject to interpretation
- Engineering Dept was outsourced
- Hanger lighting designed for DC-3's
- Lack of adequate manpower – **Fatigue** / 2 Jobs
- Lack of knowledge- just two hours of NDT training.
