## Seven Years in the Life of a TSB Investigator - Part 5

### #11 Even Safety Nets Can Kill

### **#12 The Heli-Skiing Accident**

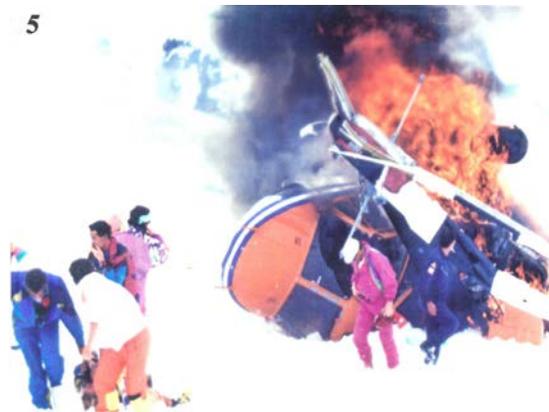
No one was hurt in the crash but on releasing their seatbelts they dropped into a pile with the 5 snowboards that were on board. A fierce fire erupted in the engine compartment and suddenly survival called for getting out as soon as possible.

However, a fire immediately started that resulted in 3 fatalities. The fire was due to a 90 degree aluminum fuel fitting breaking and releasing fuel under pressure that immediately ignited. It was attached to a steel fitting at the firewall and had it been made of stainless steel it would have been 8 times

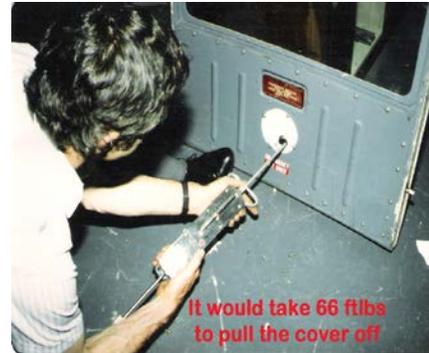
You be the judge regarding maintenance whose error may not have contributed but very well could have. The cover over the emergency exit handles are made of plastic that, as they vibrate, wear and begin to fall off. It seems that on other aircraft as well as the accident one, a keen AME put washers under the holding screws so the covers would not fall off. Tests carried out on the modified cover revealed that it now took 66 ft lbs to remove the cover.

Imagine having one finger in the one inch hole and having to pull 66 lbs to remove it. One person did put his finger in one but he tried to turn it without success. The other maintenance error that could have contributed to fatalities was the headrests were all fitted with pippins (quick release pin) that allowed the headrests to be adjusted for height and to go down and turn sideways in an emergency. One was fitted with a bolt and self-locking nut. No one knew how to lower the headrests because they had not paid attention to the Safety video.
