Volume 4 Issue 49

December 22, 2008

SAFETY INFORMATION NOTICE (SIN)

Flashlight Hazard by Overheating

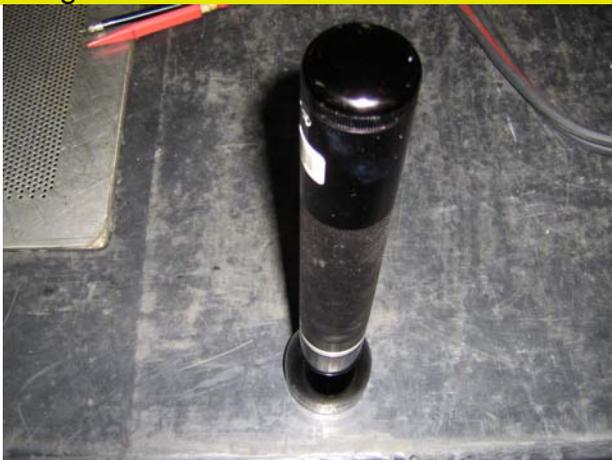
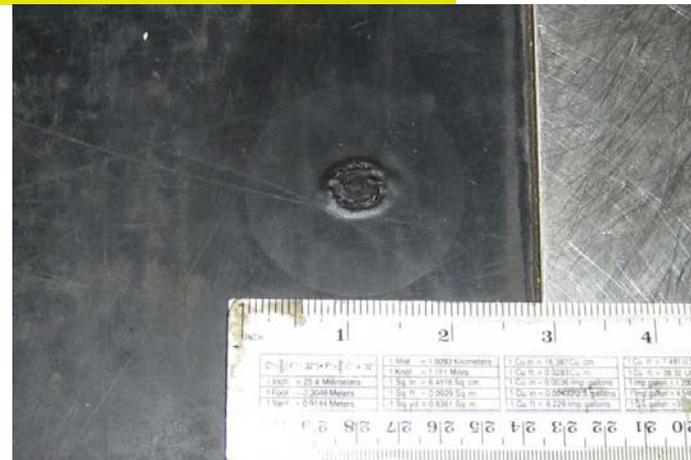
Recently a MagLite 6V 2.5 AH rechargeable Flashlight was inadvertently left switched on and standing on its lens assembly. After a short period of time a burning plastic smell was detected and traced to the flashlight. The lens area of the flashlight had become overheated and scorched the vinyl bench-top. The incident highlighted a significant fire hazard; particularly had it gone unnoticed or occurred after hours.

Investigation revealed that a number of other flashlights have similar potential for overheating due to their high light output, magnifying lenses and switches which allow continuous operation.

Applicable users of similar high light output flashlights are encouraged to consider preventative measures such as toolbox training, warning labels, spring loaded switches and/or safe modification to the lens assembly as appropriate to prevent upright storage.
