Aviation Human Factors Industry News

October 26, 2006

Vol. II, Issue 37

Improperly Routed

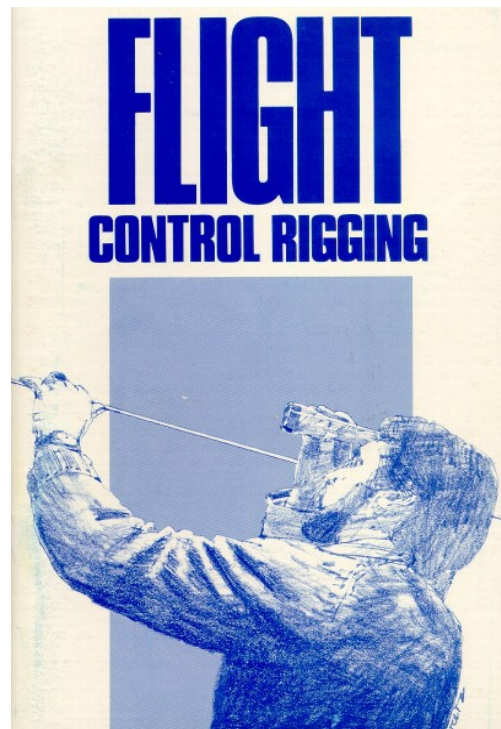
An inspection revealed that "the elevator down cable was improperly routed at the pulley in the vertical stabilizer, just below the elevator bell crank". The resultant binding had caused the cable to "wear against a guide until the cable failed". The aircraft had undergone an inspection 10 days prior to the incident. A review of the inspection checklist revealed that "the elevator cables and related components were inspected with no anomalies noted". Upon discovery of the improperly routed cable, the operator checked the other 18 aircraft in their fleet. No similar discrepancies were found.

Aircraft maintenance records established that the elevator cable had been installed by another operator on Feb. 4, 1998, as required by Airworthiness Directive (AD) 87-02-02. Key Lime Air, Inc. maintained the aircraft under a manufacturer approved continuous airworthiness inspection program. On March 24, after its "Letter Check E" inspection, the aircraft got a clean bill of health.

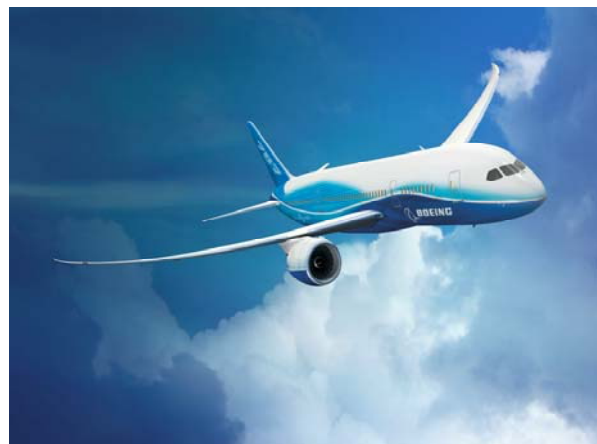
That information will be displayed on five large screens measuring 15.1 in. diagonally twice the size of those on the 777 that will give pilots not only a new level of the view ahead but also of what is behind. "If pilots need to make an emergency go-around, they instantly know what the terrain is all around them," Sinnett says. During that emergency turn, when flightcrews normally would be blind momentarily to the weather toward which the aircraft was turning, the Rockwell Collins WXR-2100 MultiScan Radar solves this problem by using SmartScan to scan just in the direction of the turn, thus ensuring quick re-visit times.

The real beauty, says Sinnett, **is that pilots will have all the information they want on one screen without having to scroll to get the total picture.** The screens are capable of displaying large-format maps with a range of 1,280 mi. (2,370 km.) and flightcrews also can bring up complete airport taxiway maps without having to scroll. The additional screen space allows for overlaying weather data without obscuring vital navigation information and there will be screens for displaying ATC communications and advisories to remind crew to comply with those instructions.
